INSTALLATION RESTORATION PROGRAM
PHASE I: RECORDS SEARCH

LAUGHLIN AIR FORCE BASE
TEXAS

March, 1985

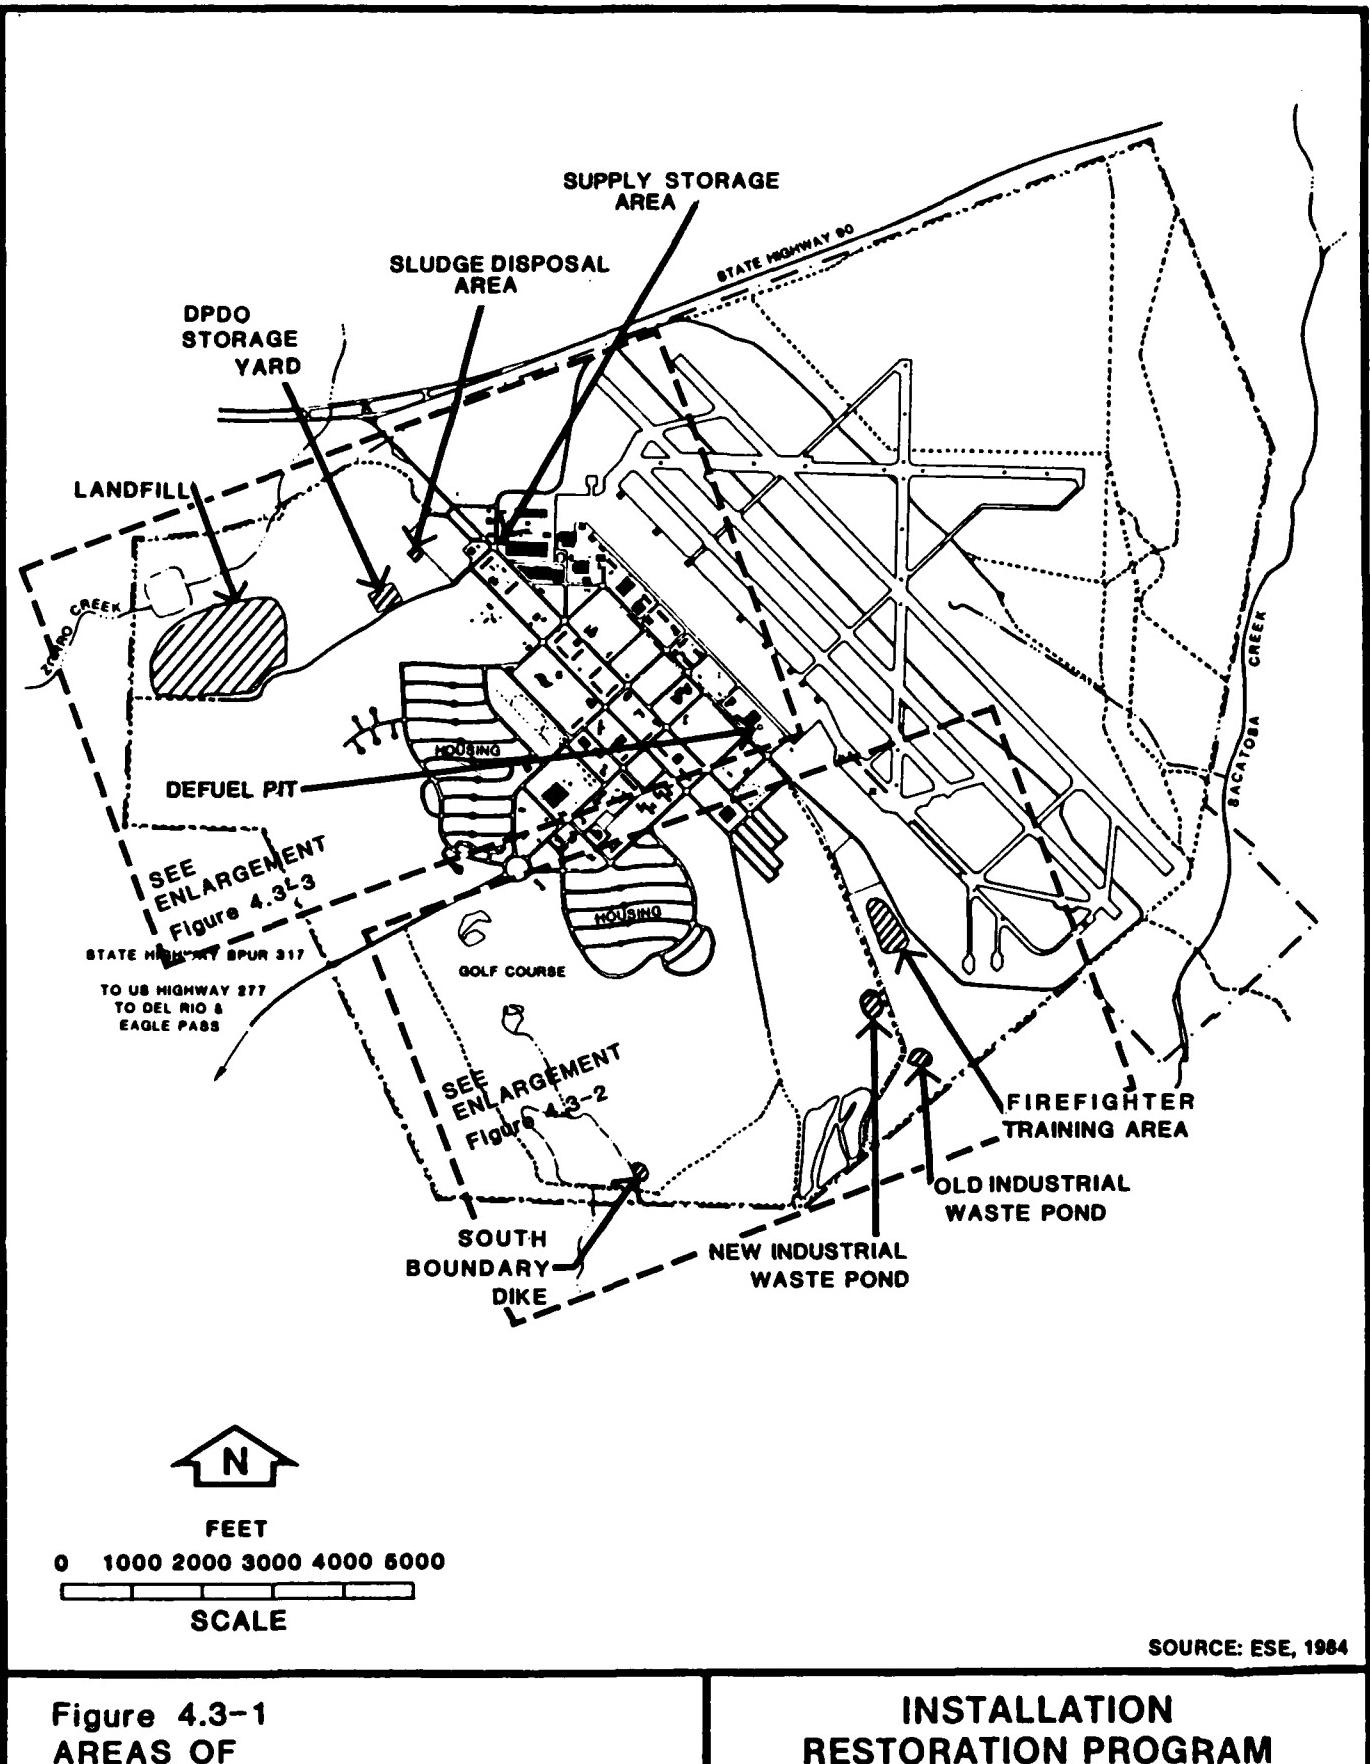
Figure 4.3-1
AREAS OF
POTENTIAL CONTAMINATION

This study identified nine areas on LAFB subject to potential contamination by industrial and/or hazardous waste as a result of handling and disposal practices. Figures 4.3-1 through 4.3-3 illustrates the location of these areas. Aerial photographs of each site are included in Appendix E. No areas of potential contamination were found at EPAux.

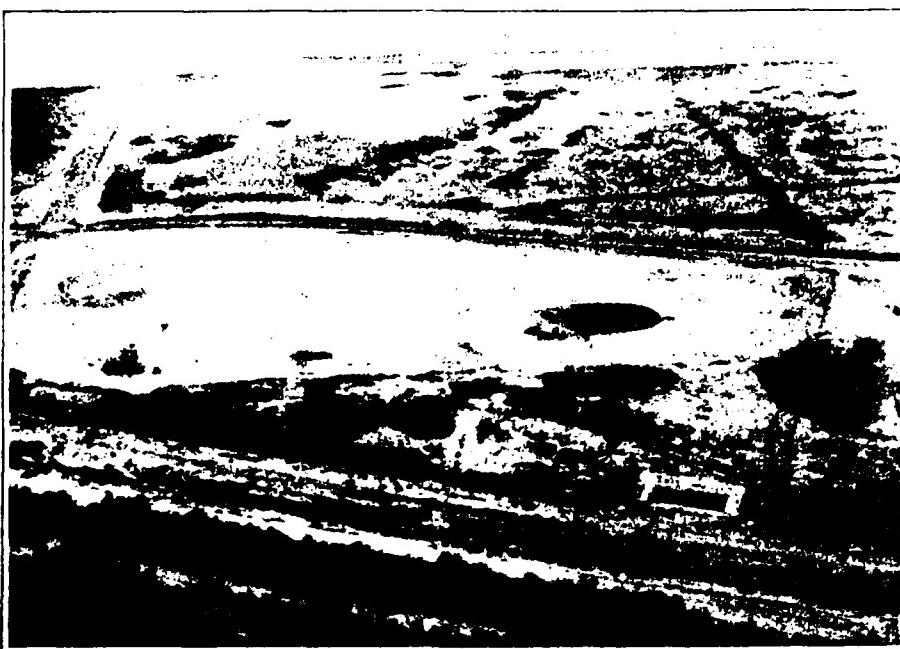
EXISTING FFTA

The area utilized a surface depressions as firefighter training sites until 1983 when the current, fully contained, site was constructed. Fuels used in exercises included MOGAS, AVGAS, JP-4, JPTS, engine oil, transformer oil, and solvents. Surface soil permeability is 0.6 to 2.0 in/hr. Ground water conditions are not clearly defined. Soil contamination is likely, and some potential for migration exists. The HARM rating for this site is 52.

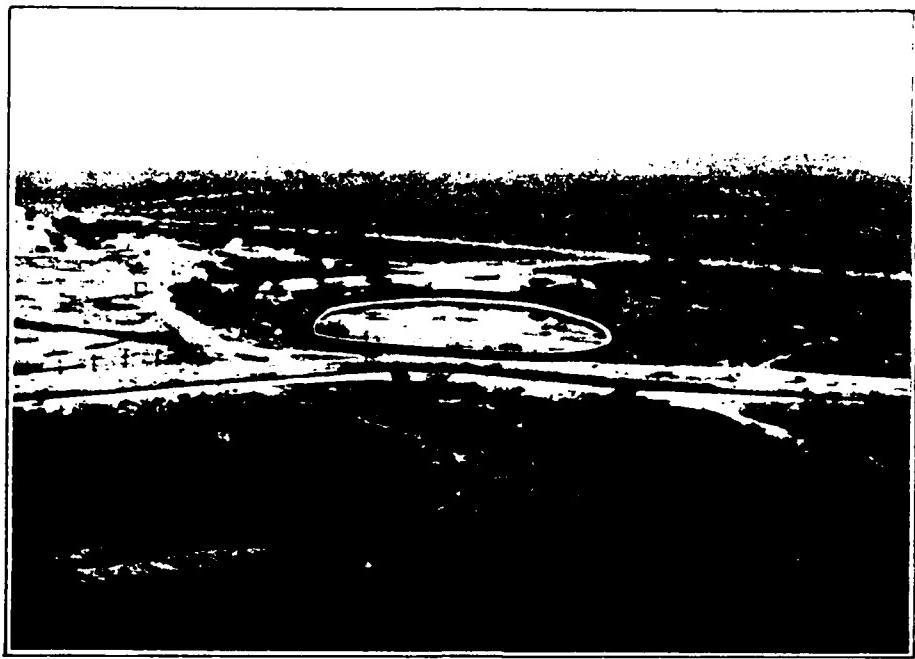
OLD IWP

This borrow pit adjacent to the main flightline drainage channel was used as an industrial waste retention pond from at least 1952 to 1976. It continued to be used as a dumping area for liquid waste until 1980. Permeability of soils is 0.6 to 2.0 inches per hour (in/hr). Ground water conditions are unclear. Potential exists for contaminant migration, primarily involving metal plating and paint wastes and some oil, solvent, and pesticides. The HARM score for this site is 63.

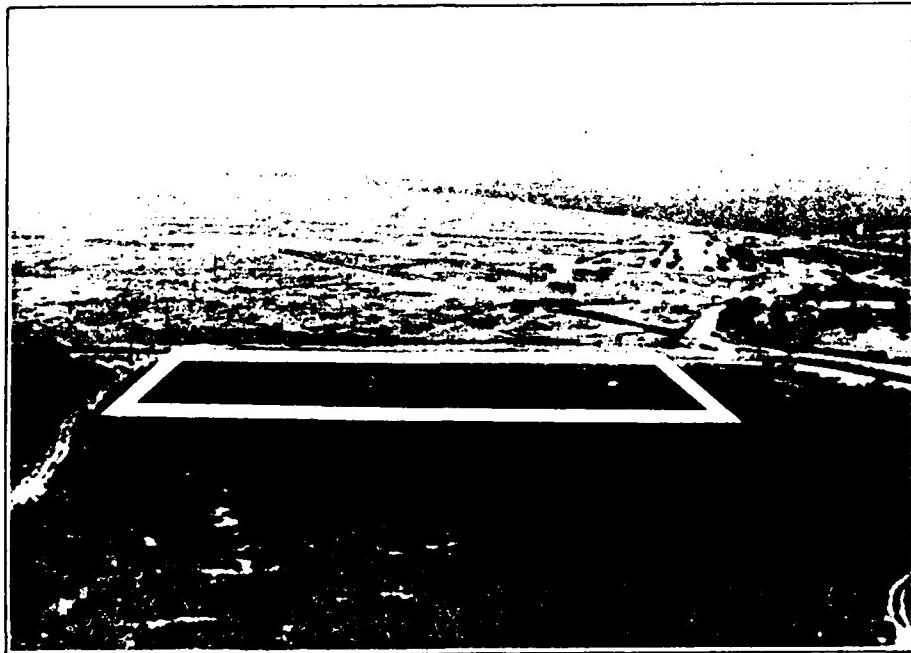
NEW IWP

This pond was used to retain liquid waste and drainage from the flightline from 1972 to 1976. It was also used as a dumping area for chemical cleaning and plating shop wastes. Permeability of surface soils is 0.6 to 2.0 in/hr. Ground water conditions are unclear. Potential for migration exists, primarily for solvents and metals and possibly for oil and pesticides. The HARM score for this site is 51.

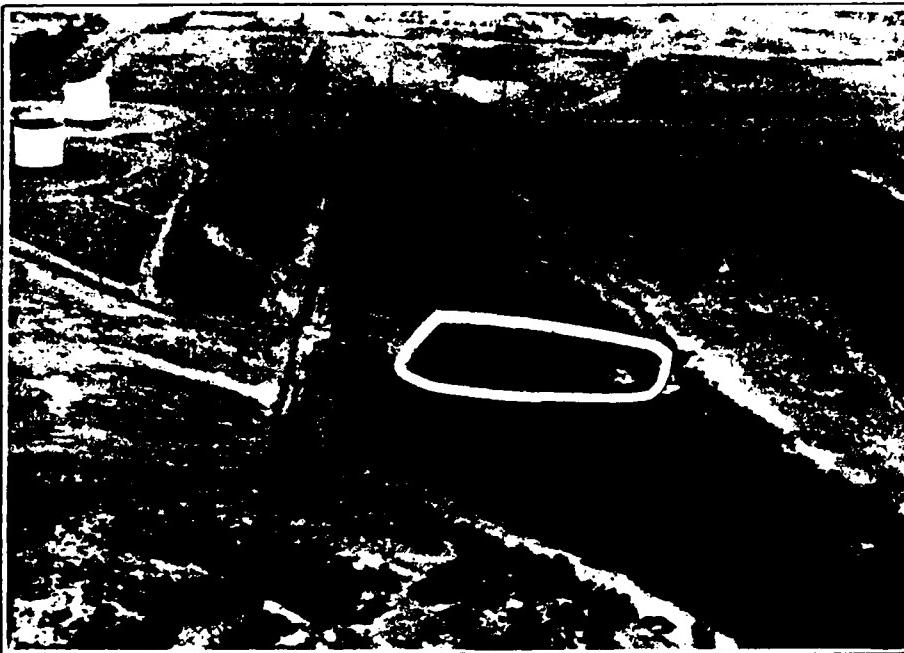
SLUDGE DISPOSAL AREA

This is a shallow, diked area which has historically been used as a dumping area for sludge generated during tank cleaning operations. Soil permeability is 0.6 to 2.0 in/hr. Ground water conditions are unclear. Soil contamination is likely, primarily from metals. Some potential for migration exists for JP-4 and metals. The HARM rating for this site is 44.
